**CWA COMPLIANCE EVALUATION INSPECTION REPORT
U.S. ENVIRONMENTAL PROTECTION AGENCY, REGION 5**

Compliance Evaluation Sampling Inspection

Sandway Farm, LLC

April 18, 2013

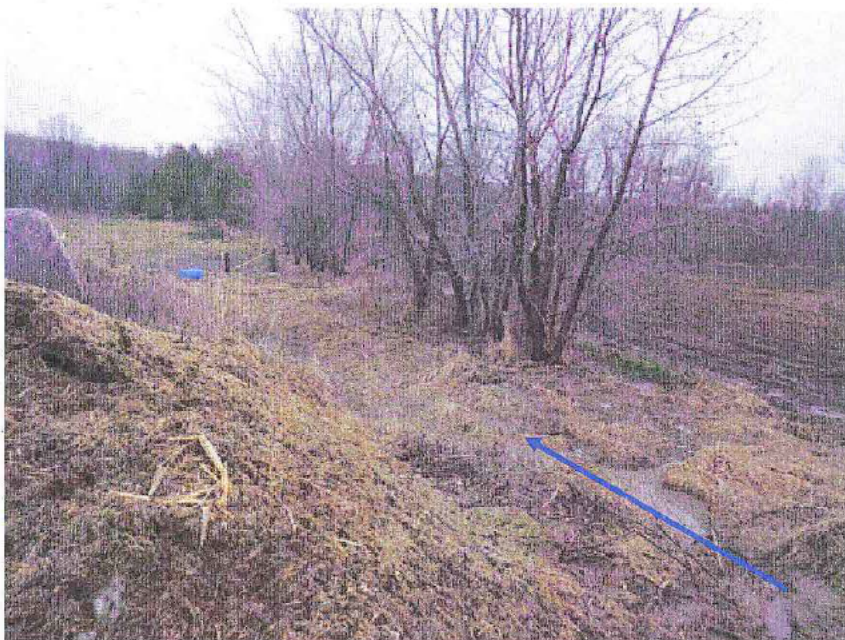
IMGP0125: Flow from manure in feed bunker flows to the West Ditch (indicated by blue arrow). Waste silage is piled up with snow along the West Ditch. West Ditch flows into Pasture #1.

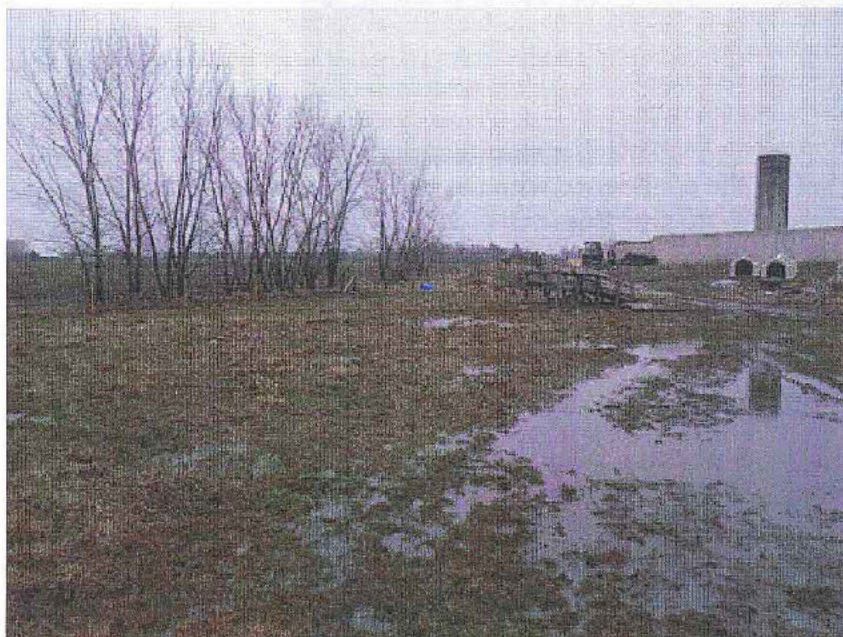
IMGP0141: Flow that goes south from the piles of silage flows into Pasture #1.

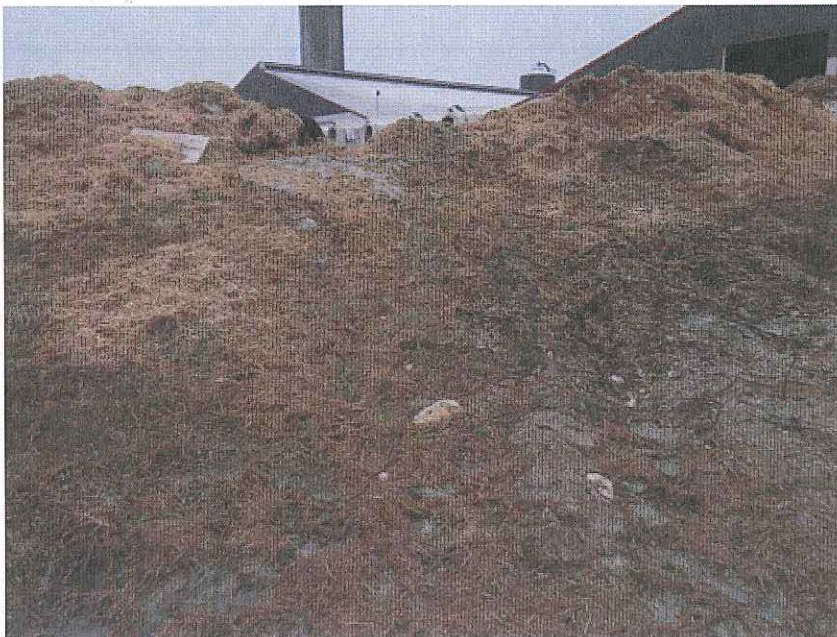
IMGP0175: Pile of snow with used bedding allows process wastewater to flow down the hillside into the northwest corner of Pasture #3.
